# State of Safety Report **2018/19**

# CHIEF EXECUTIVE OFFICER'S FOREWORD

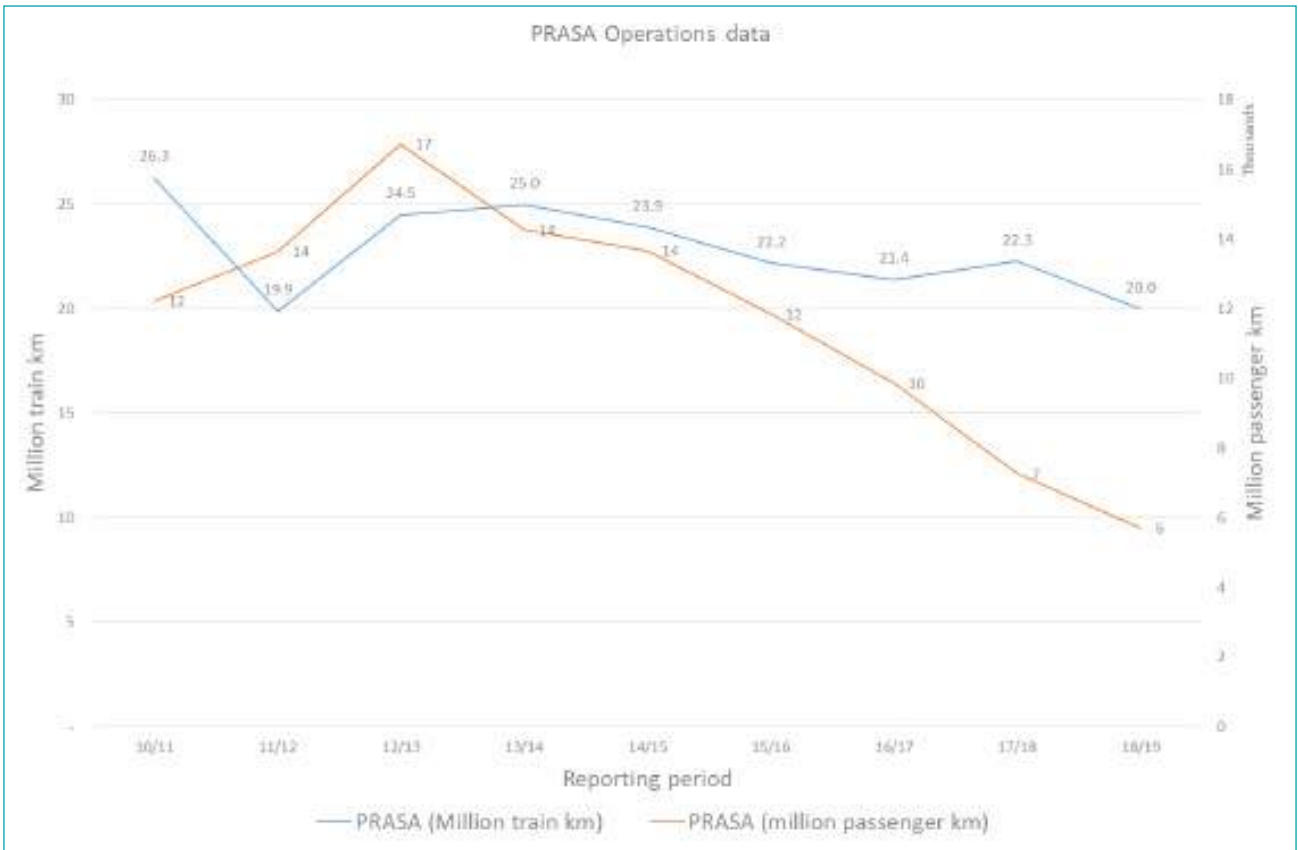
Figure 2: PRASA operations data

Table 4 and Figures 1 to 3 provides details of the traffic volumes and productivity levels for the period 2010/11 - 2018/19, as submitted to the RSR by the two major operators, namely TFR and PRASA. When examining the annual train kilometres per operator from 2010/11 to 2018/19, interesting trends for each of the operators are revealed.

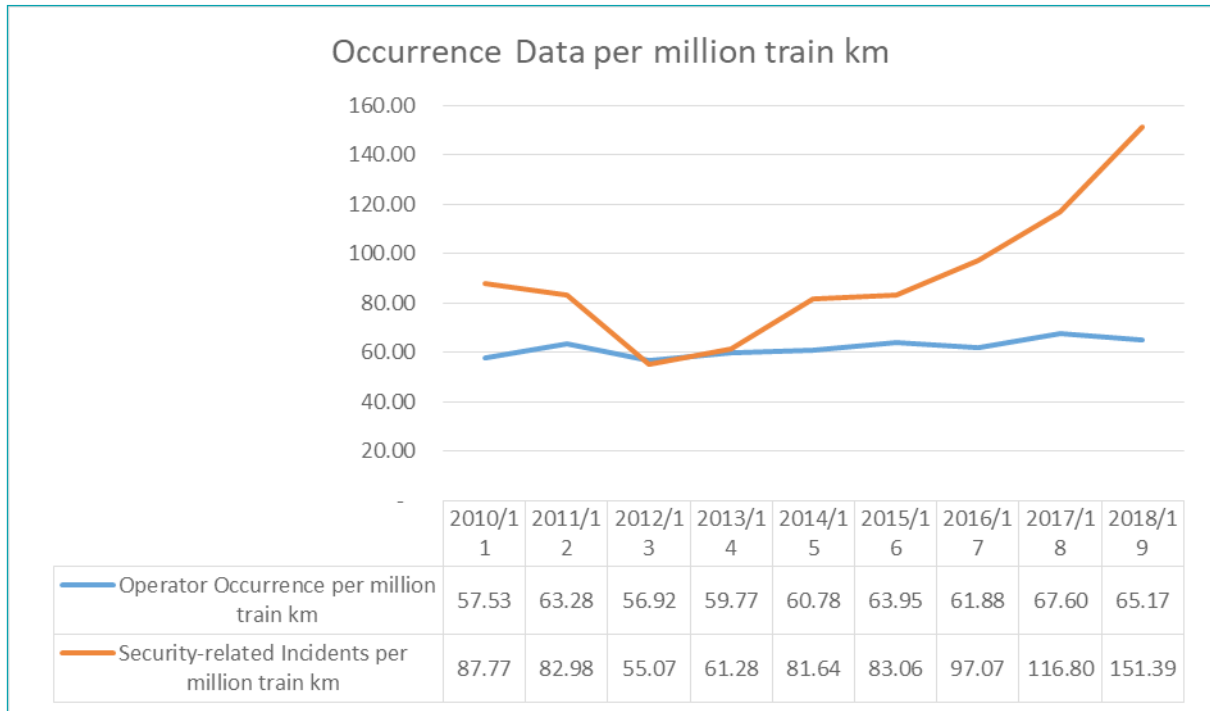
Figure 4: Occurrence data per million train km for the reporting period

Figure 4 shows that, while in the following six years since 2012/13 there was an overall 20 per cent reduction in network traffic, operator occurrences per million train km increased marginally to 65,17 (14 per cent increase) and security-related incidents per million train km increased dramatically to 151,39 (175 per cent increase).

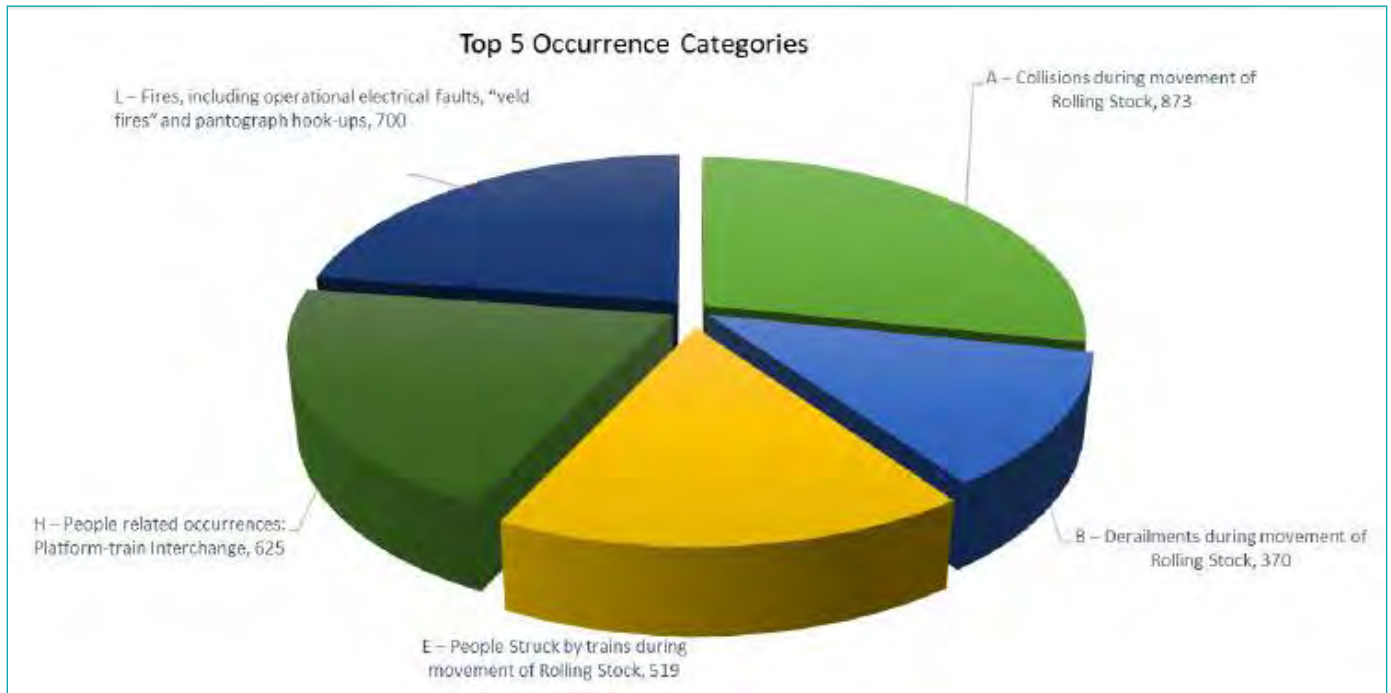
**Figure 7: Top 5 occurrence categories for 2018/19**

Figure 7 shows the Top 5 categories for safety occurrences for 2018/19.

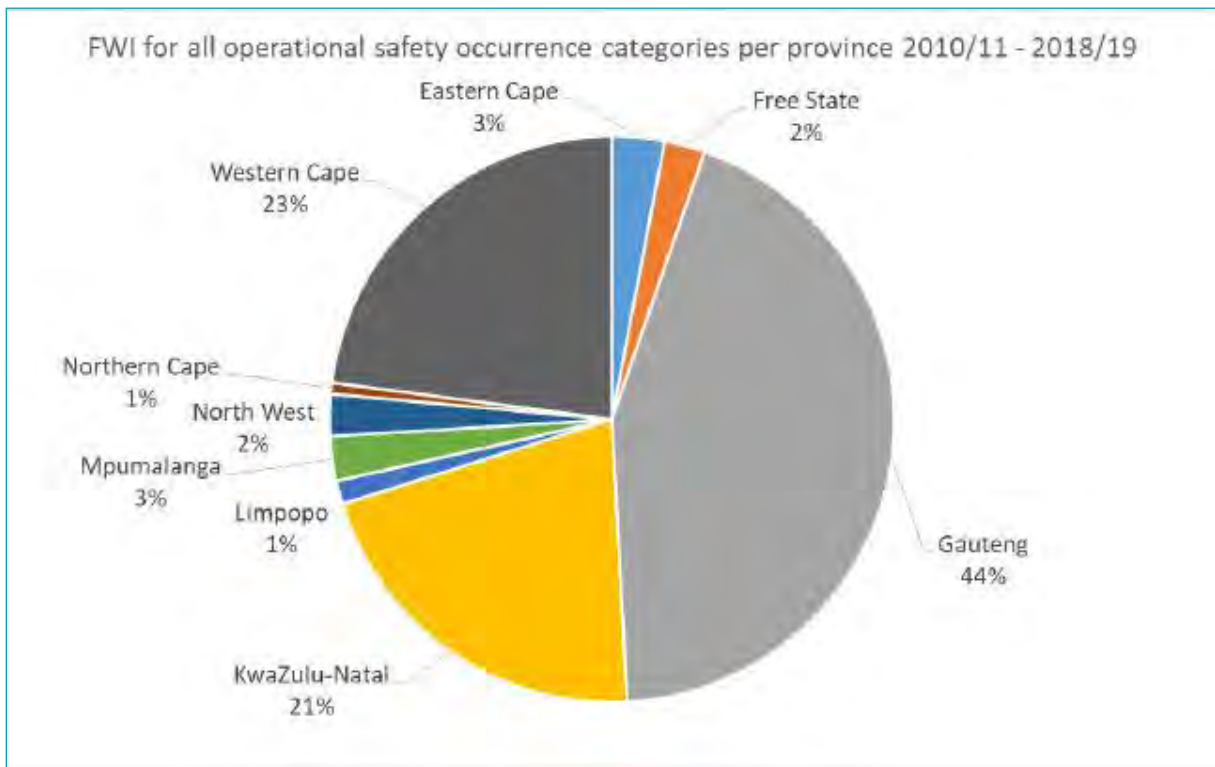
Figure 11: FWI for all safety occurrence categories per province 2010/11 - 2018/19

Figure 11 illustrates how the FWIs for all the operational safety SANS occurrence categories vary per geographical location. The three large metropolitan cities in the Gauteng, KwaZulu-Natal and the Western Cape provinces, with high commuter traffic volumes, recorded 88 per cent of the FWIs. Figure 12 illustrates PRASA's productivity levels in the same provinces.

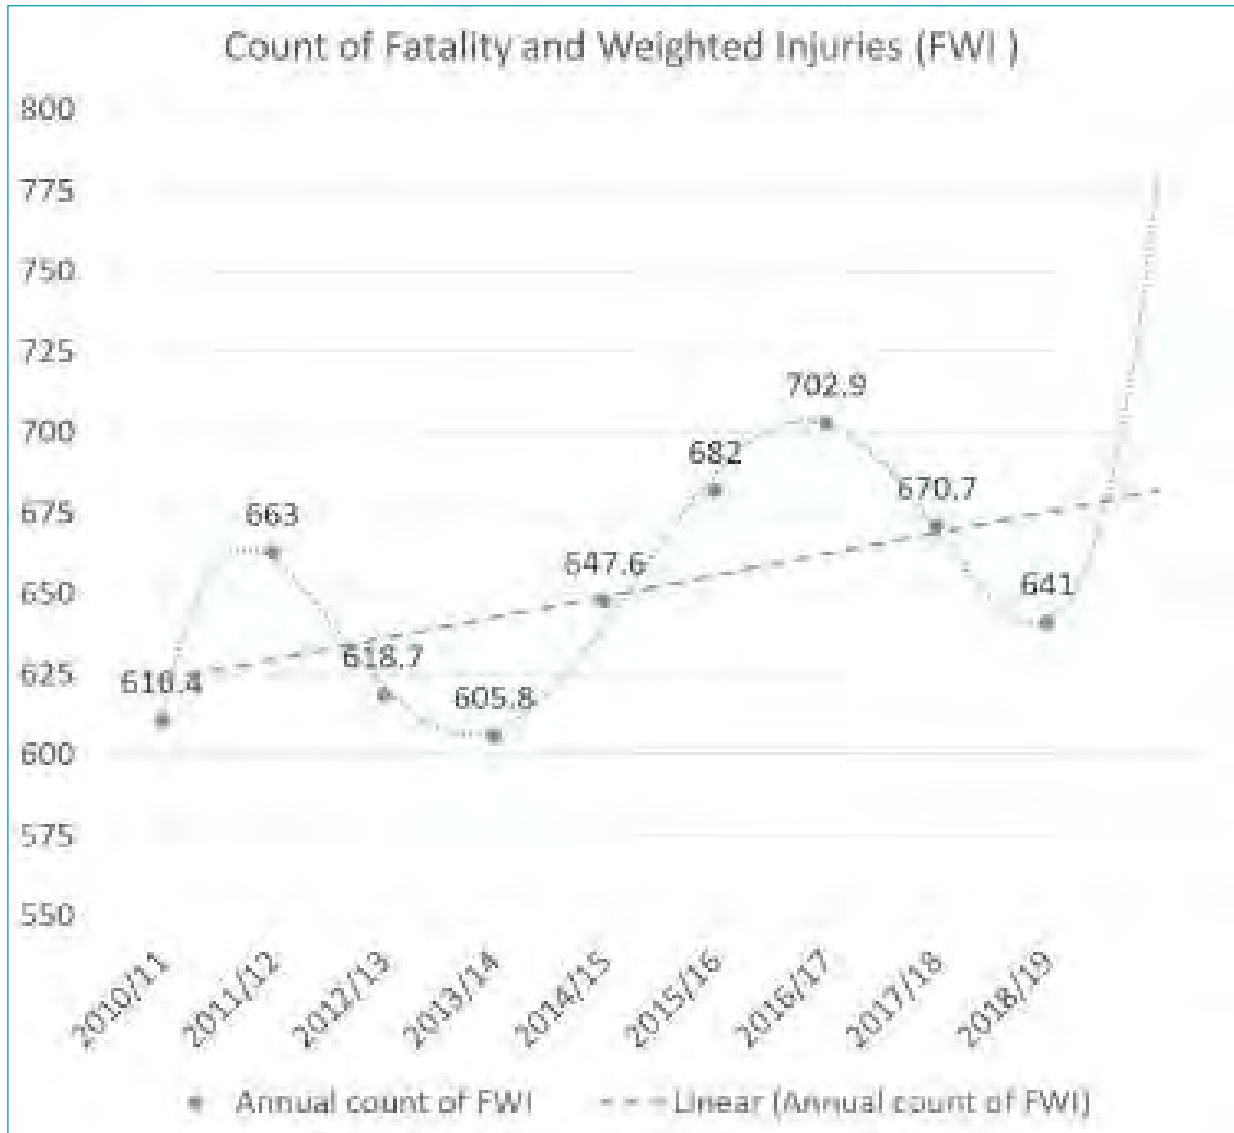
Figure 13: FWI trend for 2010/11 - 2018/19

Figure 13 shows the FWI for the 2010/11-2018/19 Financial Years. A near-perfect curve fit and a simple linear trend are also shown. Based on historical performance, unfewer significant interventions take place, the FWI for 2019/20 would increase to just above the 2017/18 level and could escalate out of control.

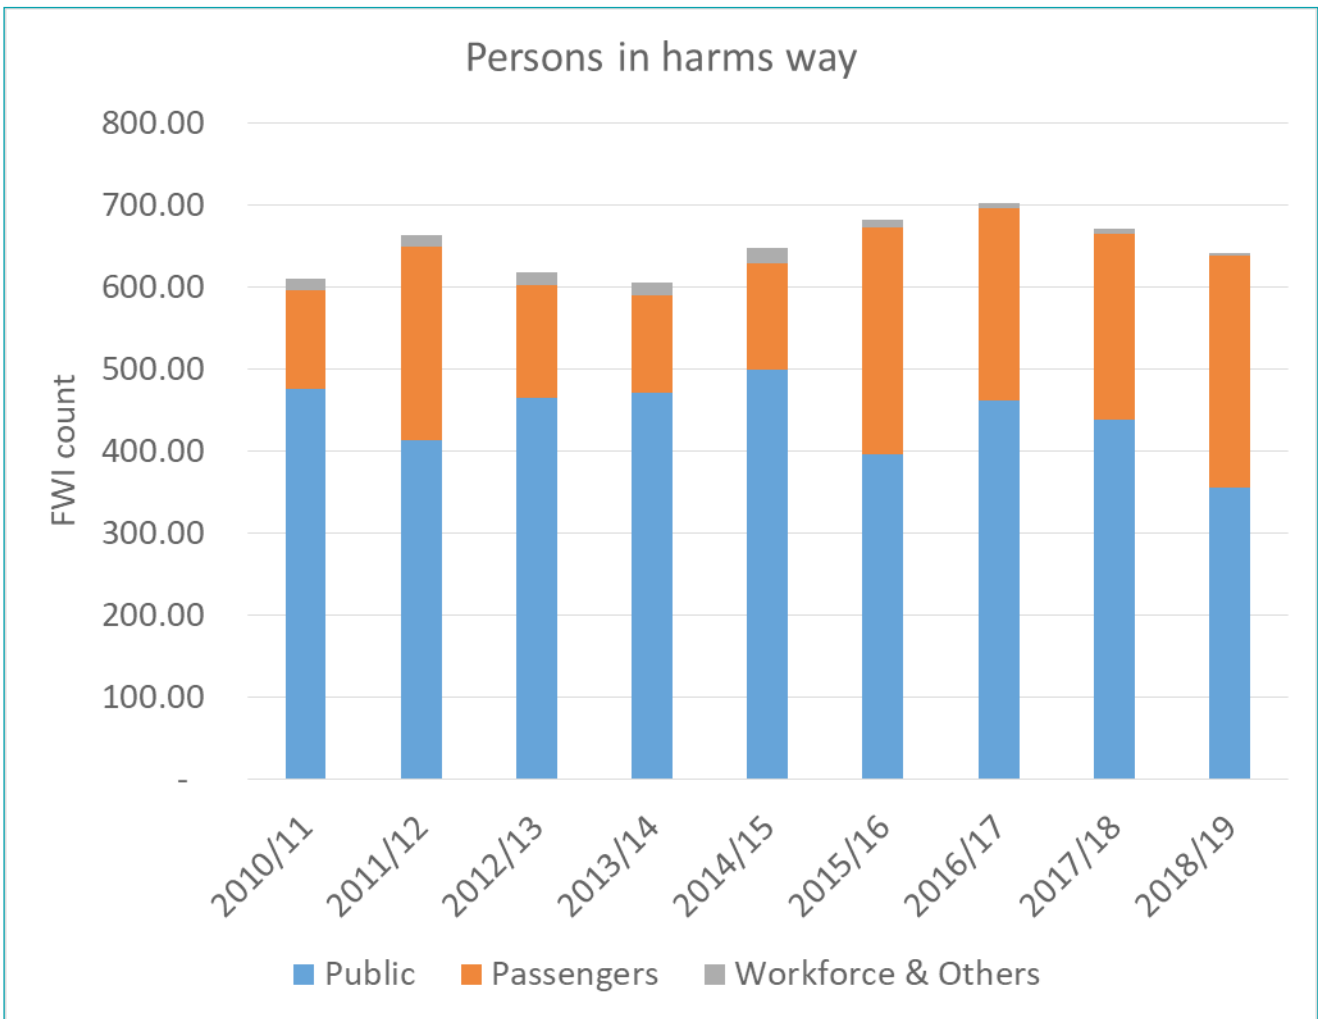
Figure 14: Persons in harm’s way 2010/11 to 2018/19

Figure 14 shows a marked increase in harm to passengers and a reduction in harm to the general public since the 2015/16 Financial Year.

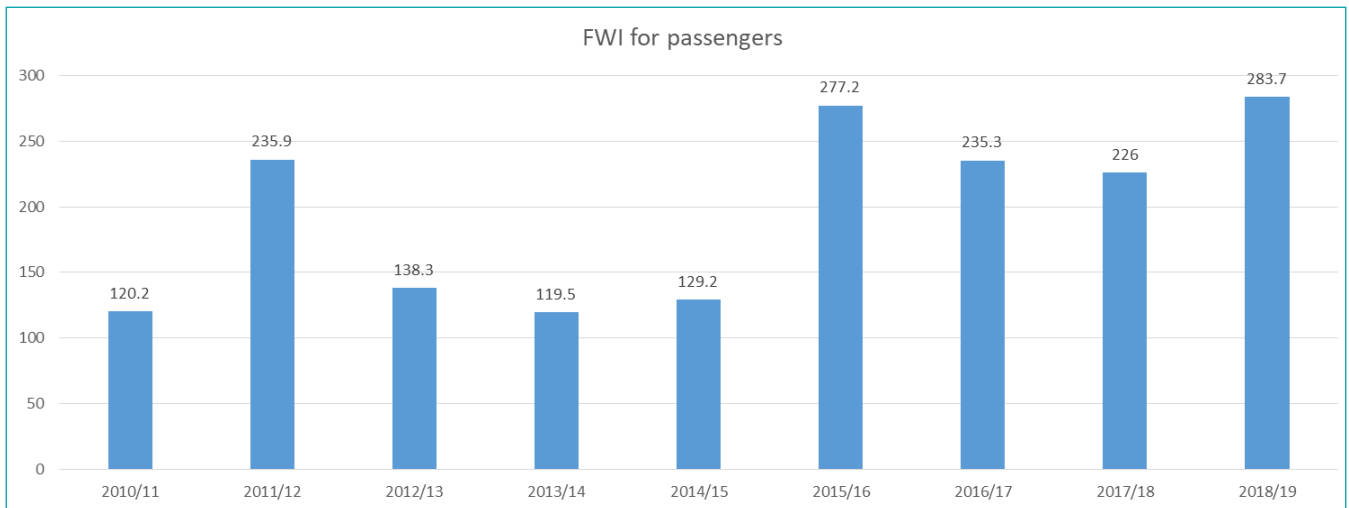
Figure 15: FWI for 2010/11 - 2018/19

Approximately 5 720 million passenger kilometres were recorded for 2018/19. Figure 15 illustrates that passengers account for 30 per cent of FWIs for the 2010/11-2018/19 reporting period. An increasing trend in passenger FWIs can be observed for this period.

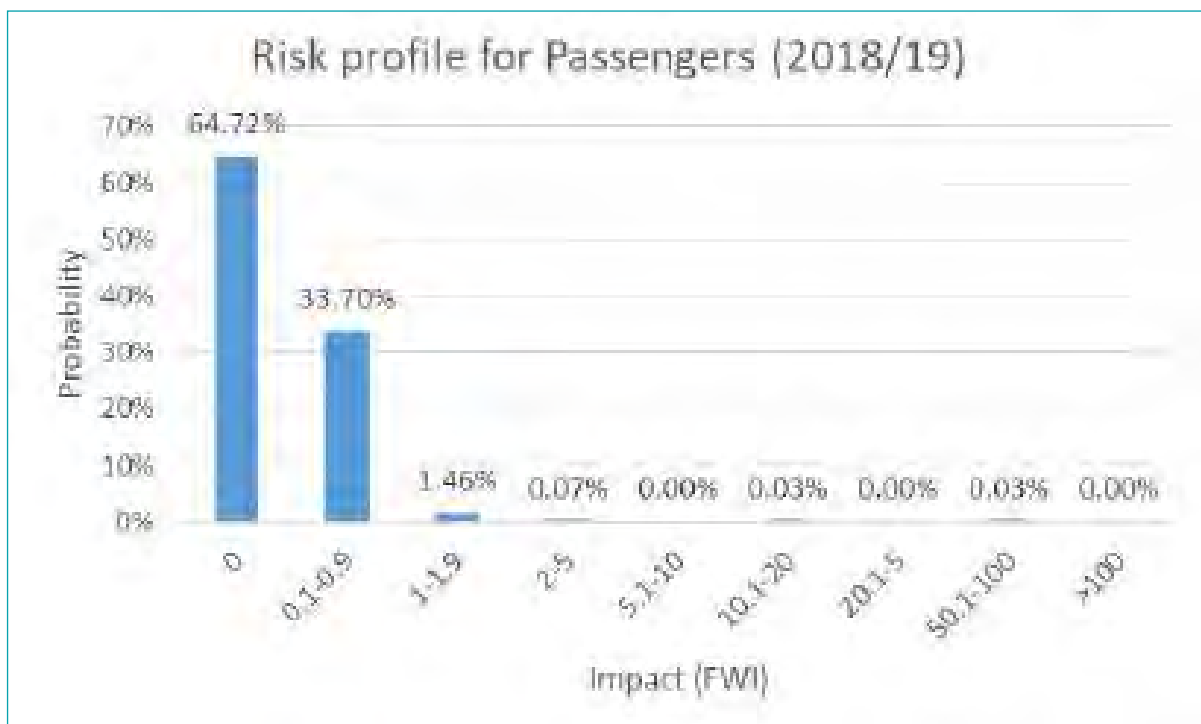
Figure 16: Risk profile for passengers (2018/19)

Of all the persons harmed (641 FWIs) as a result of operational safety occurrences in 2018/19, 46 per cent (283,7 FWIs) were passengers. Figure 16 illustrates the risk profile for passengers for the reporting period 2010/11 to 2018/19.

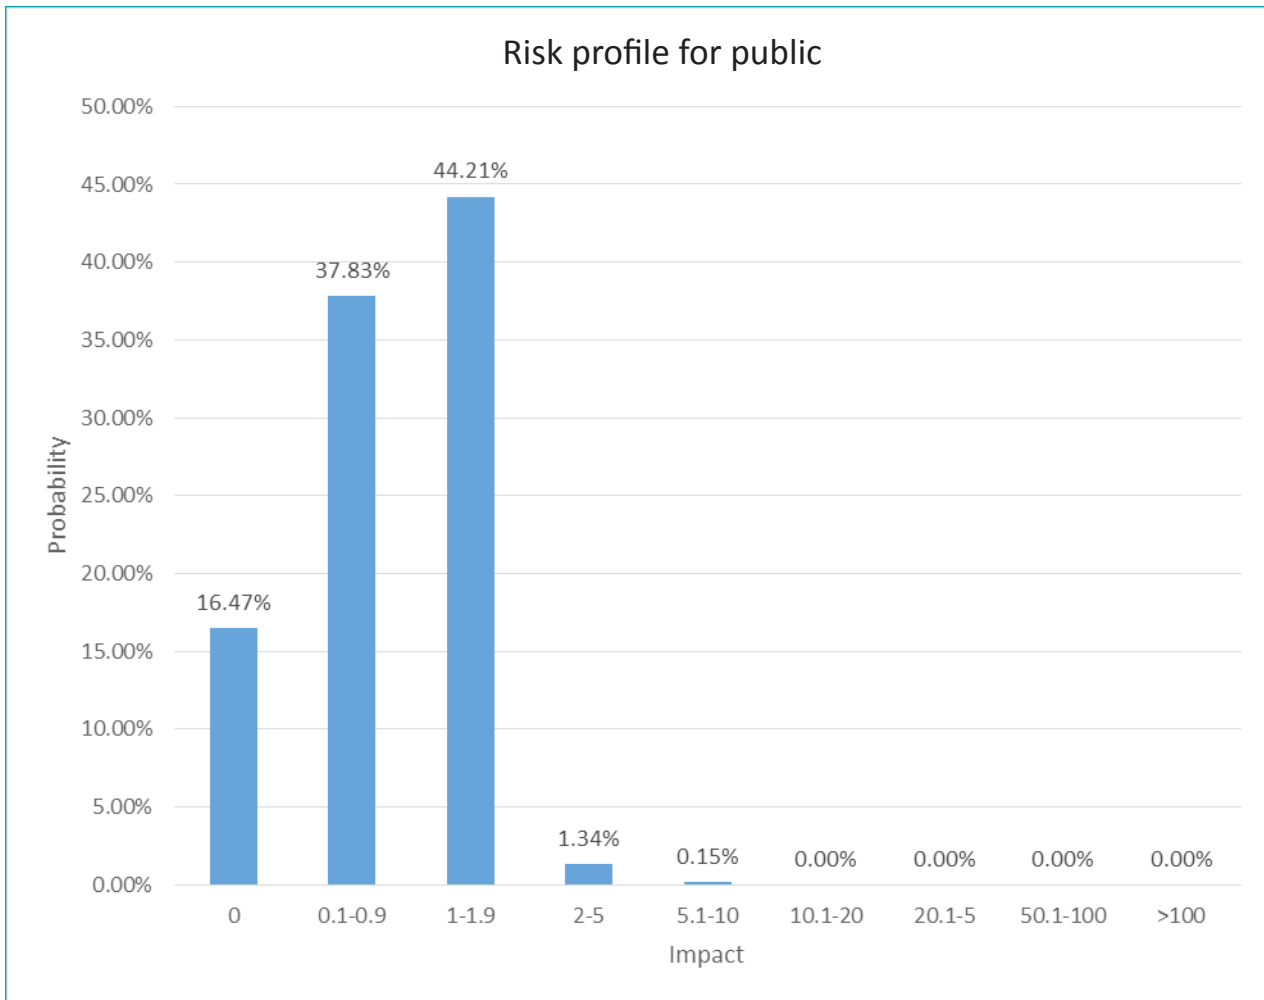
Figure 20: Risk profile for the general public (2018/19)

The risk profile for the public (2018/19) in Figure 20 shows that once public-related operational occurrence happens, based on a Fatalities and Weighted Injuries index basis:

- The public was harm free in only 16,47 per cent of these operational safety occurrences;
- Fewer than one public FWI occurred in 37,83 per cent of the operational safety occurrences;
- Operational occurrences associated with one to two public FWIs have a probability of 44,21 per cent.
- Operational occurrences associated with more than two public FWIs have a low probability (1,49 per cent).

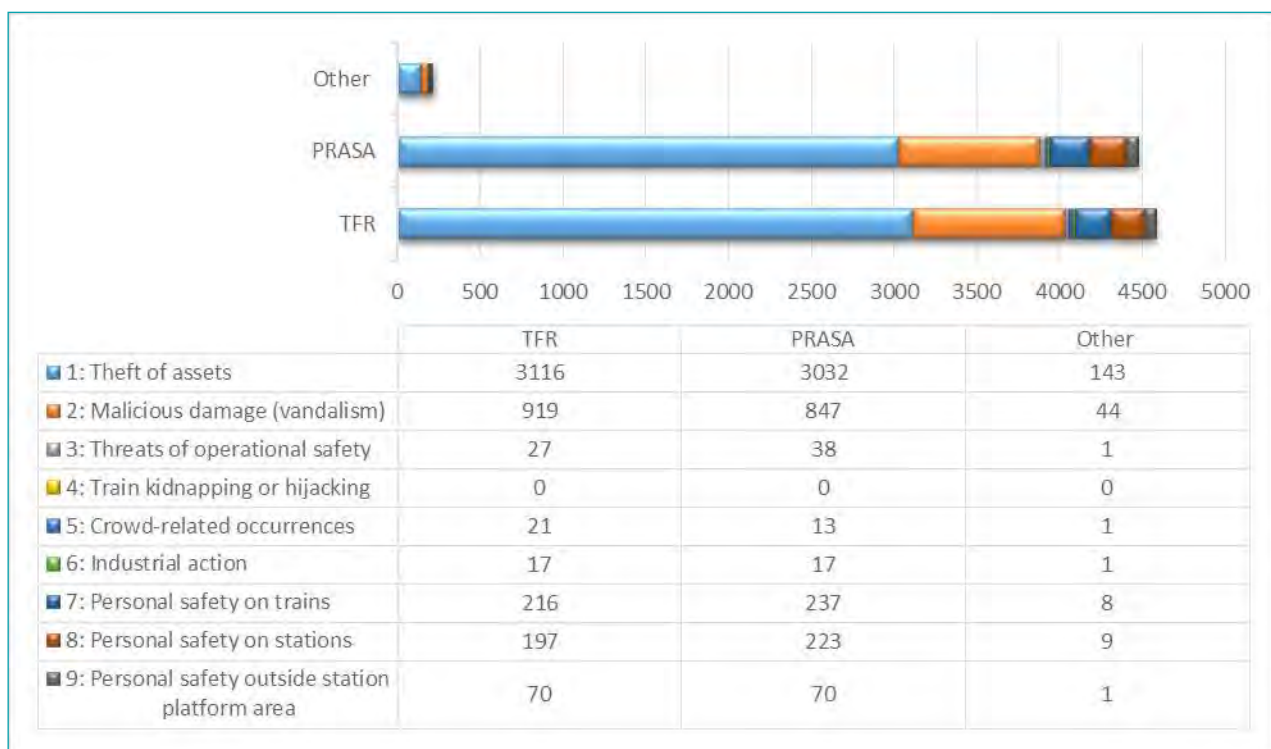
Figure 23: Number of security-related incidents per operator for 2018/19

Figure 23 shows only a 2 per cent difference in the number of security-related incidents between TFR and PRASA for 2018/19.

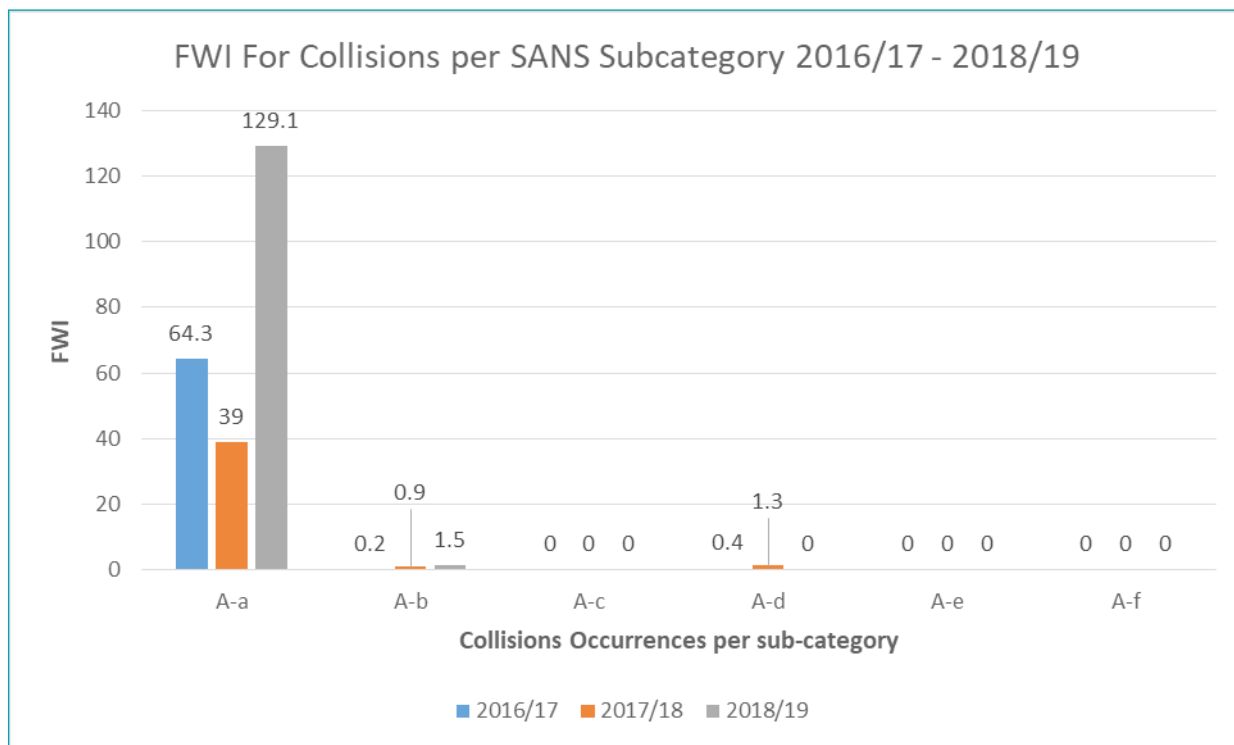
Figure 29: Percentage contribution of each train collisions SANS Sub-category to the overall FWI for train collisions for the 2010/11-2018/19 reporting period

However, when investigating which train collisions sub-category was responsible for the most harm during the reporting period, a very interesting picture emerged. Figure 29 illustrates that Collisions between rolling stock on a running line [A-a] contributed most to the overall FWI for train collisions during the reporting period. Collisions with an obstacle on a running line (including road vehicles colliding with rolling stock) and collision of rolling stock other than on a running line contributed to a very small percentage of the overall FWI.

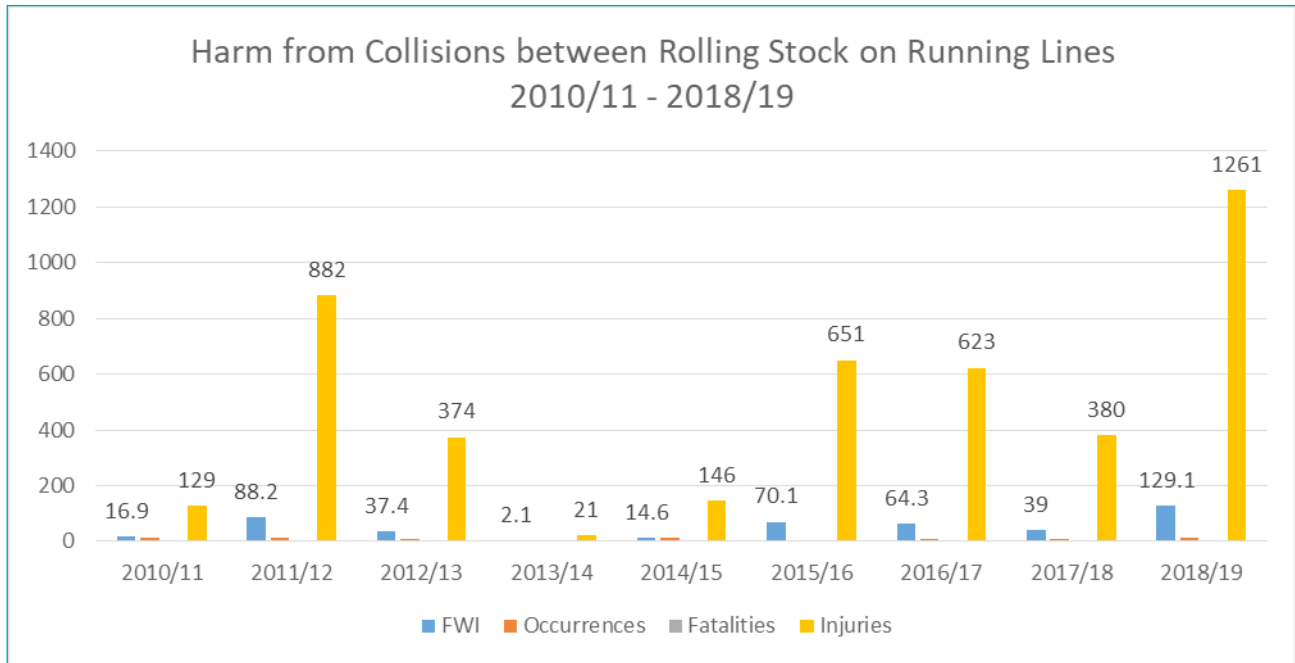
Figure 30: Harm from collisions between rolling stock on running lines 2010/11 - 2018/19

Figure 30 shows that overall harm from collisions between rolling stock on running lines (A-a) was 7,6 times worse in 2018/19 (129,1 FWIs) compared to 2010/11 (16,9 FWIs).

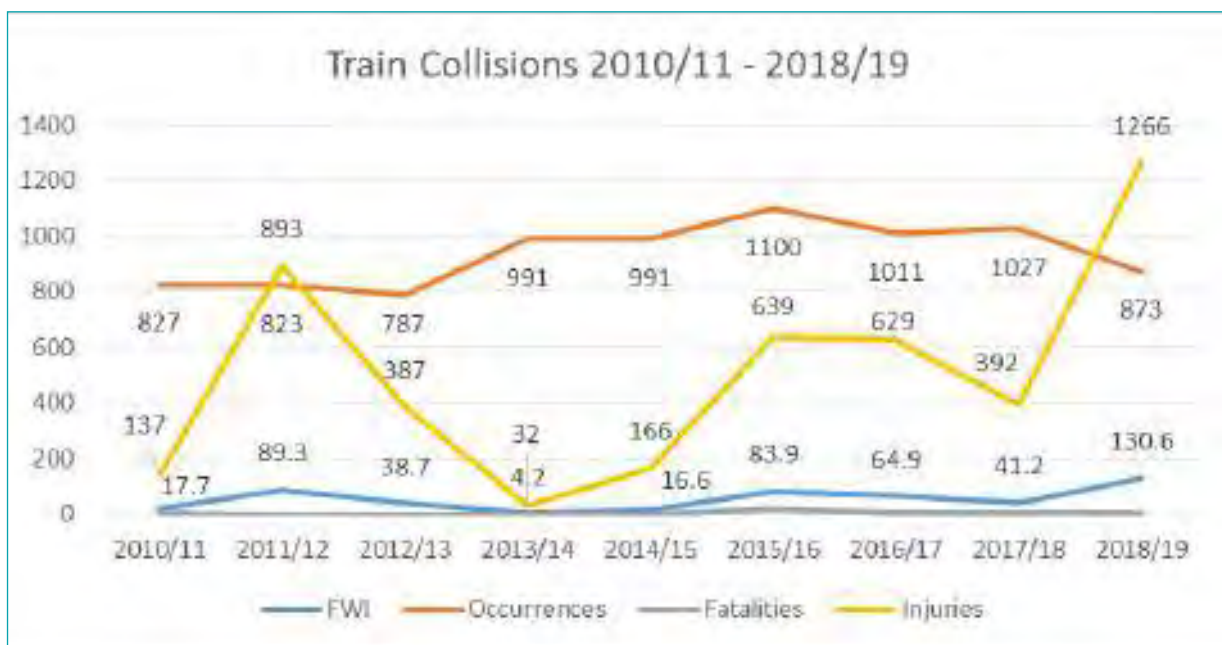
Figure 31: Number of train collisions and related fatalities and injuries 2010/11 – 2018/19

Figure 31 shows the number of train collisions and their respective consequences (fatalities and injuries) for the 2010/11 to 2018/19 Financial Years. This figure indicates a decreasing trend in train collisions from 2010/11-2012/13, an increasing trend from 2013/14 – 2015/16 and then a stabilisation after 2015/16. Injuries arising from these occurrences fluctuate year-on-year and are independent on the number of train collisions. Of note, fatalities arising from train collisions appear to be negligible except for the 2015/16 Financial Year (FWIs = 88,1). This anomaly is due to a single event that dominated the dataset for 2015/16 – a Metrorail collision with a taxi on a running line that resulted in 15 fatalities. The same could be observed in the 2011/12 Financial Year (FWI = 89,3). As in the previous case, a single collision (on 20 May 2011 between Mzimhlope and Phomolong) with 857 injured passengers was responsible for the high FWI value.

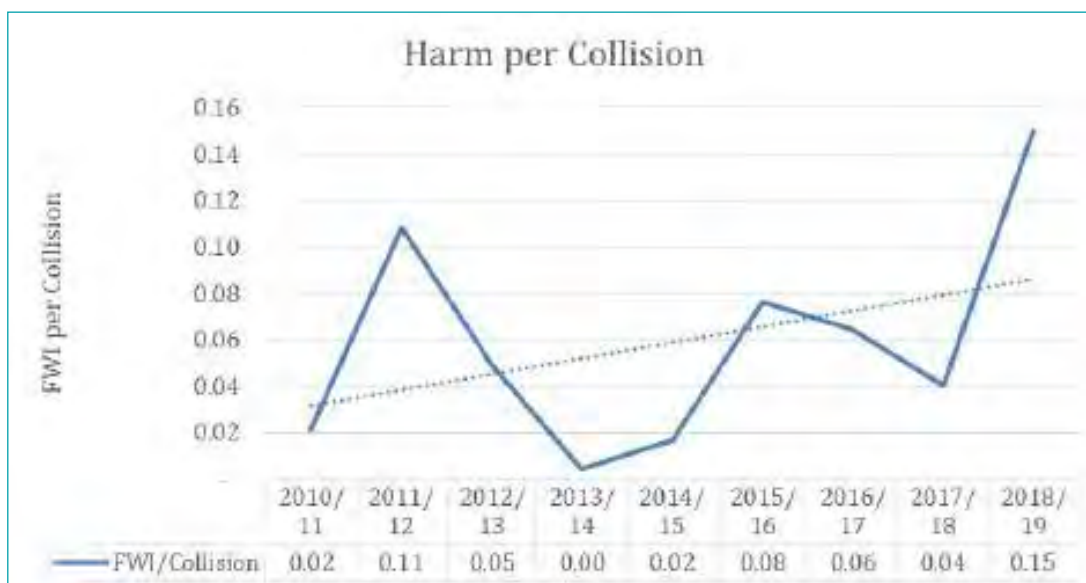
Figure 32: Harm caused per collision (FWI/collision) 2010/11-2018/19

Since 2010/11, the harm per collision has increased 6-fold (Figure 32). If the more conservative linear trend is accepted, the harm per collision will 5 - fold in 2019/20 compared to 2010/11.

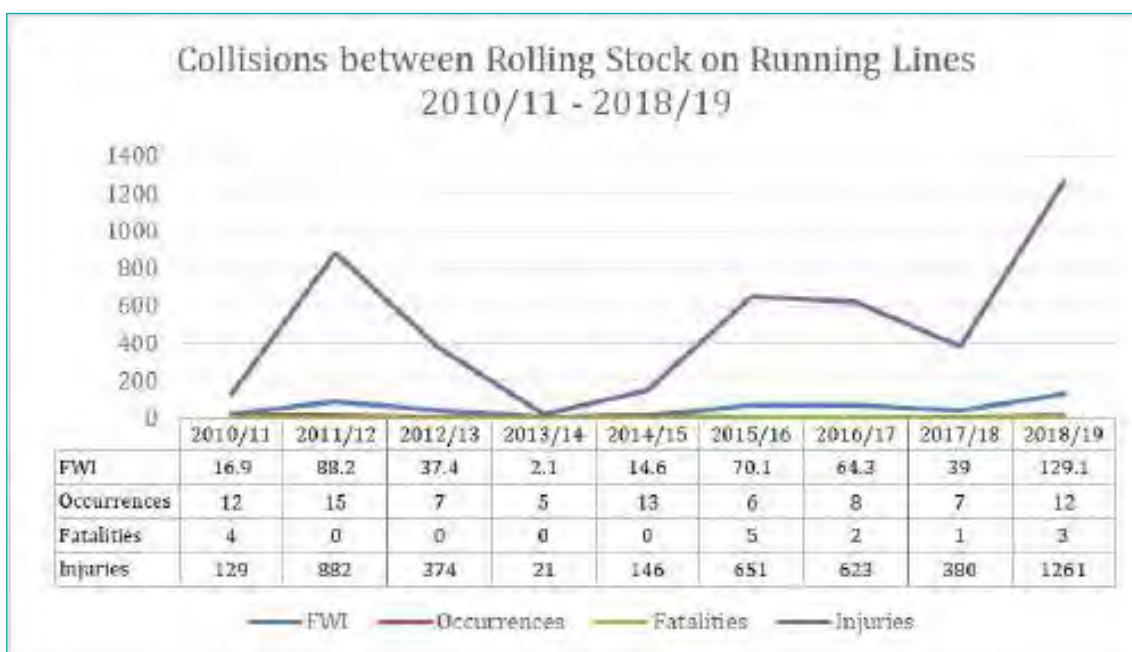
Figure 33 Fatalities and injuries vs the number of train-on-train collisions on running lines

As can be seen in Figure 33, there was an exceptionally high number of injuries in the 2011/12 – 2012/13 and 2015/16 – 2018/19 Financial Years resulting from train-on-train collisions. Whereas the 2011/12 Financial Year recorded an FWI value of 88.2 and number of injuries (882). The 2018/19 Financial Year recorded a 43 per cent higher number of injuries (1261).

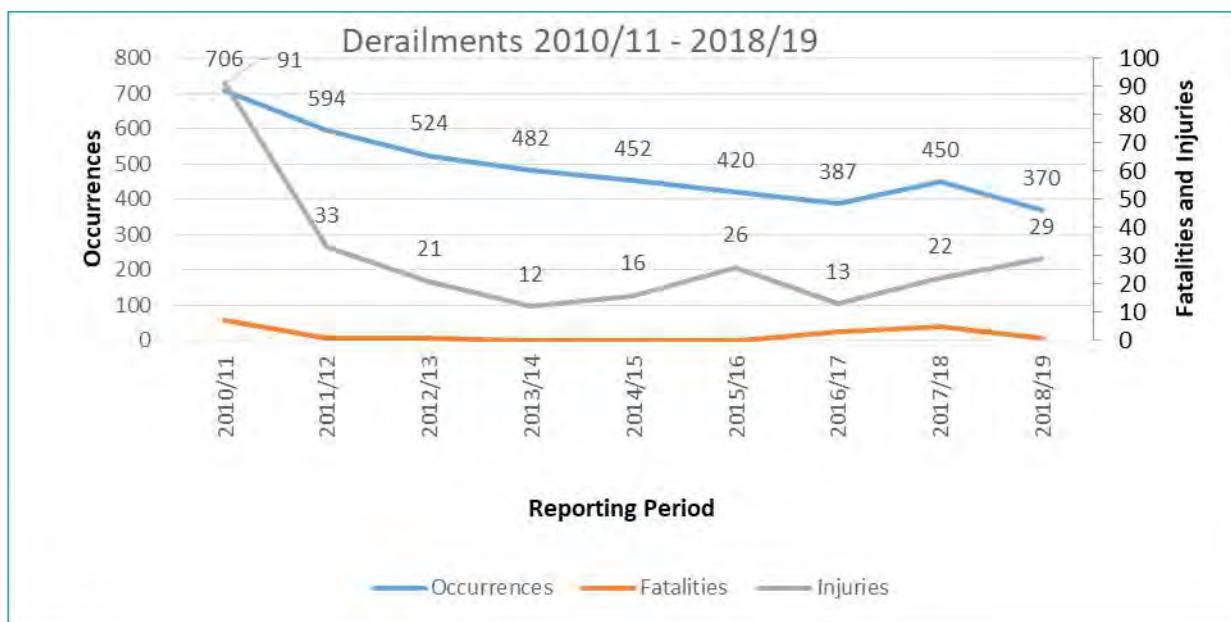
**Figure 35: Number of train derailments and related fatalities and injuries**

The consequences of the occurrences expressed as FWIs shows a similar pattern with the exception of 2015/16. The FWI value for the 2015/16 Financial Year increased due to a spike in the number of injuries (62.5 per cent increase compared with 2014/15).

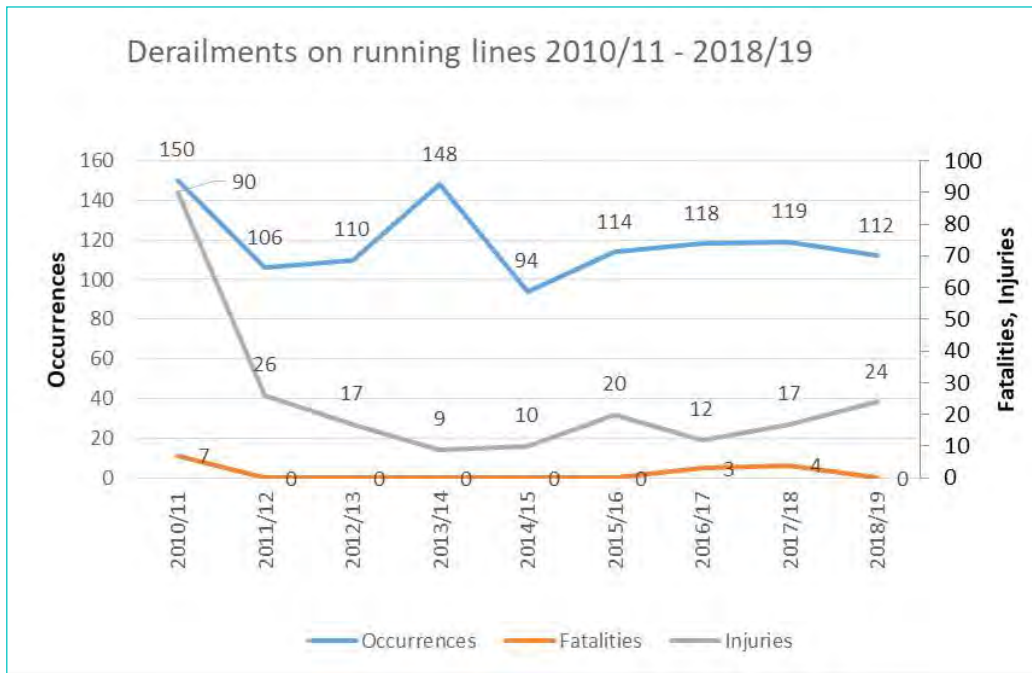
Figure 36: Number of train derailments and related fatalities and injuries

Figure 36 shows that derailment of rolling stock on a running line accounted for an average of 30 per cent of the fatalities and injuries caused by derailments. In the last year, this rose to 37 per cent.

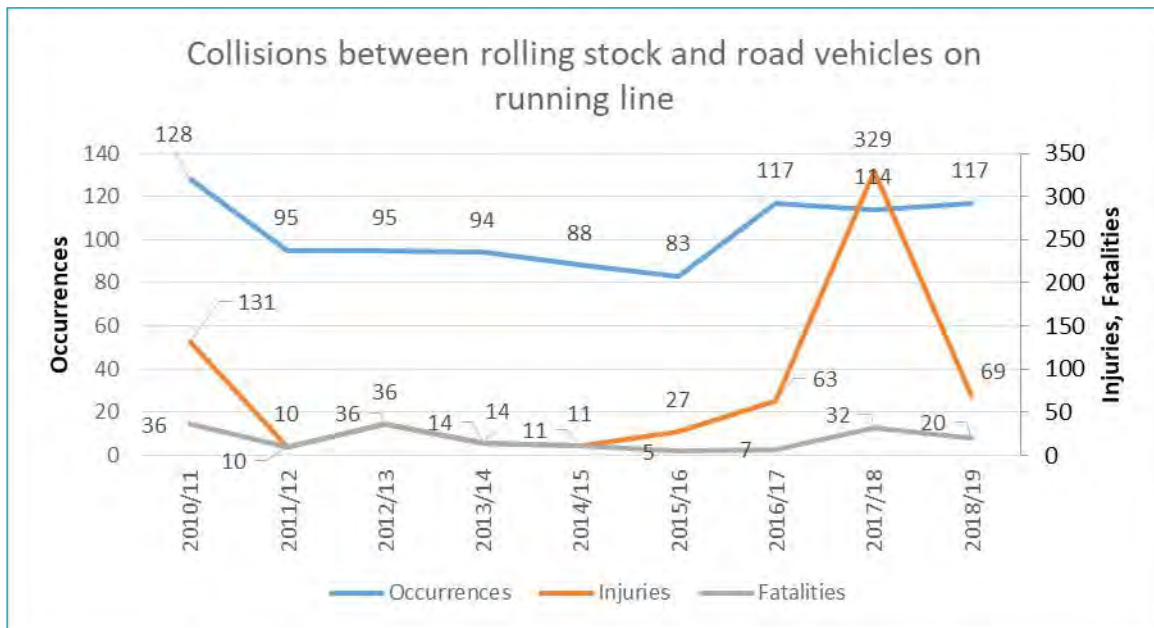
**Figure 40: Collisions between rolling stock and road vehicles on running line**

The variation in the overall trend for level crossing occurrences derives from the level crossing occurrence subcategory collisions between rolling stock and road vehicle/s on a running line (Figure 40).

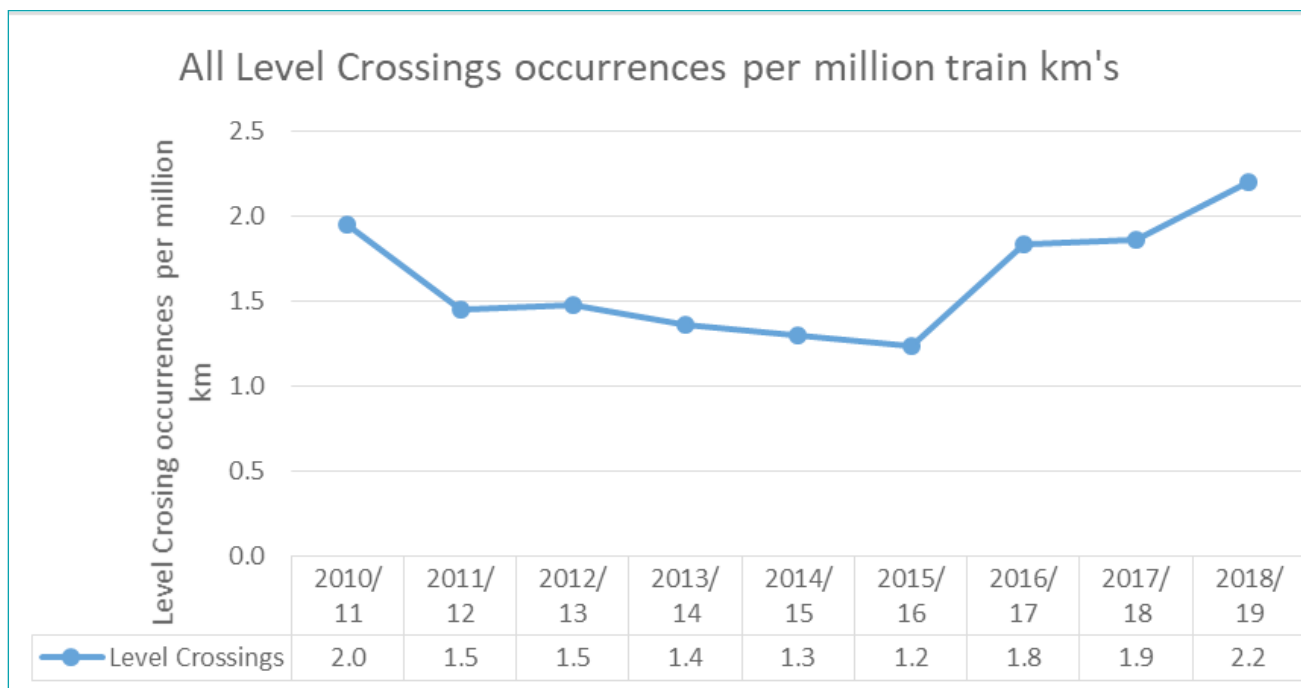
**Figure 42: All level crossing occurrences per million train km**

Since 2017/19 level crossings occurrences per million train km increased by 16 per cent, but between 2014/15 and 2018/19 this increased by 69 per cent. This upward trend is amplified as the largest operators produced fewer train km over the same period, with TFR down by 6 per cent and PRASA down by 9 per cent.

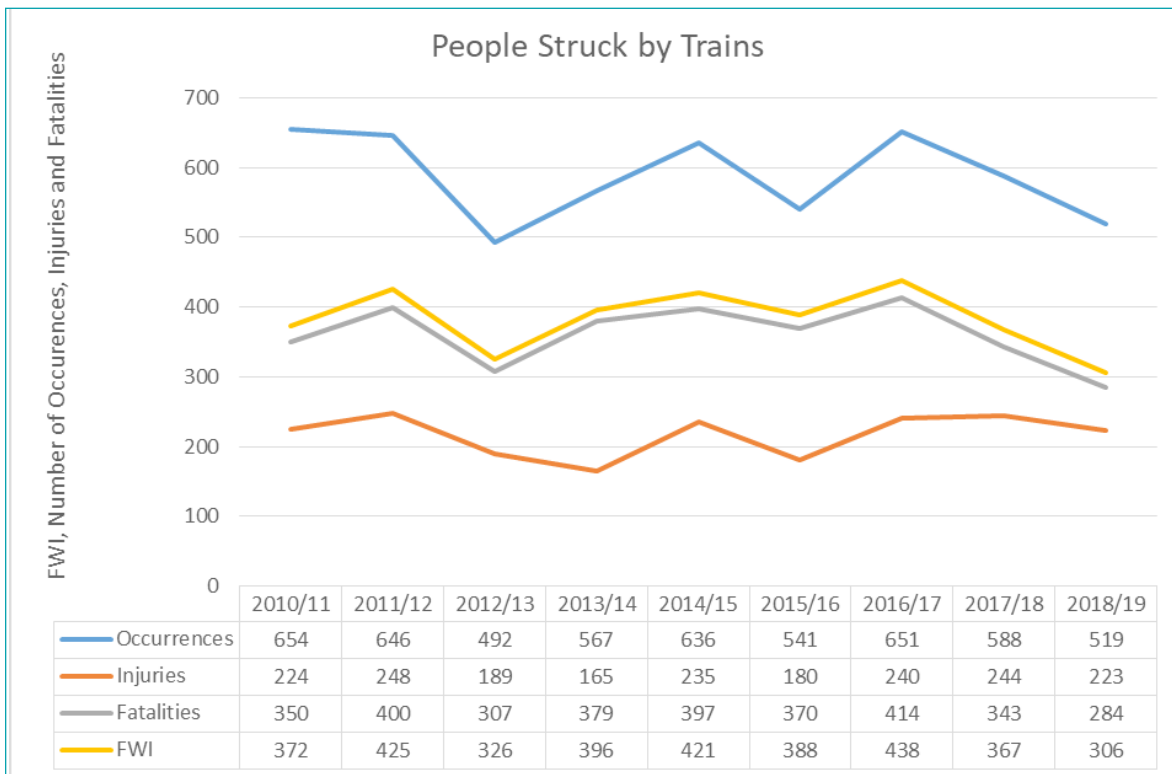
**Figure 43: Number of people struck by trains occurrences and related harm to persons**

Figure 43 illustrates the number of people struck by trains occurrences and their respective consequences (fatalities and injuries) and the calculated FWI for the 2010/11 to 2018/19 Financial Years. While the number of people struck by trains occurrences reduced by 21 per cent and the calculated FWI count decreased by 187 per cent between 2010/11 and 2018/19, the FWI per million train km reduced by only 3 per cent.

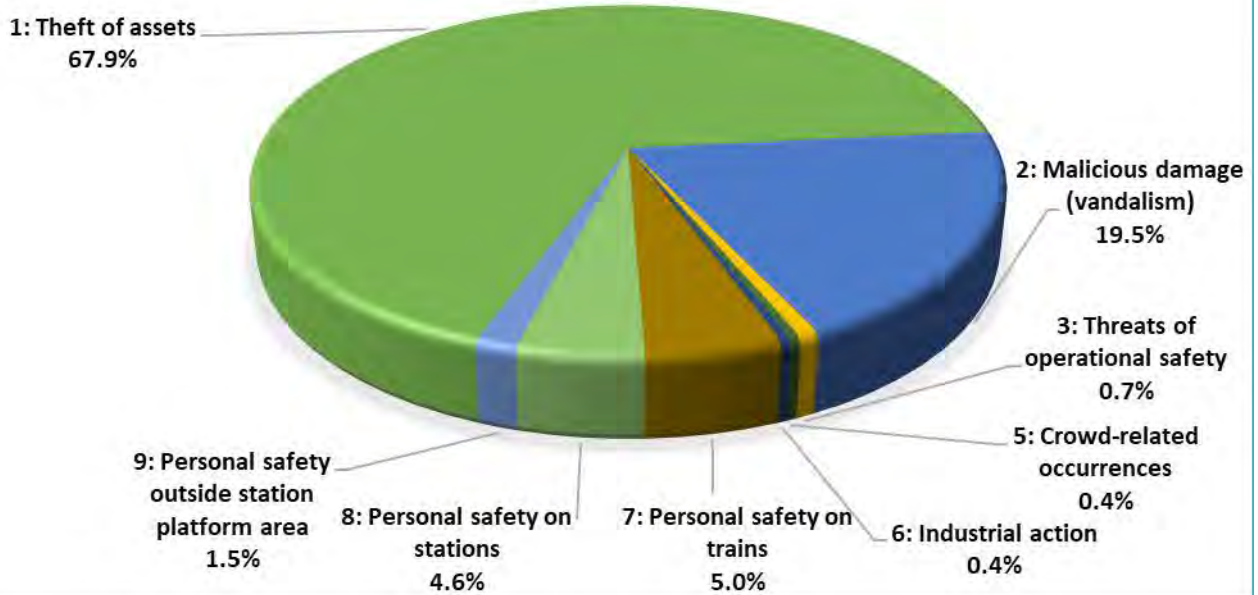
Figure 56: Breakdown of 2018/19 security-related incidents by category

The operational impact that 87 per cent theft and vandalism (Figure 56) have on train operations is significant and could be evidenced by the percentage time that TFR and PRASA operate in degraded mode.

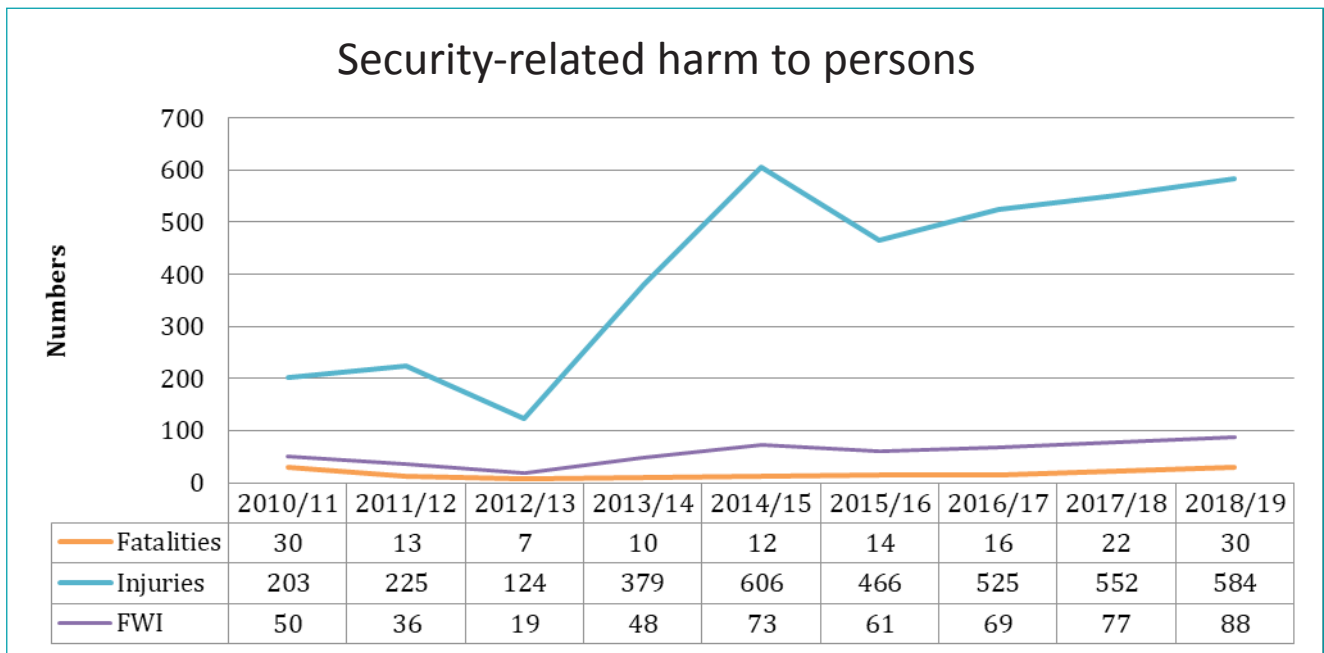
Figure 57: Security-related harm to persons 2010/11 to 2018/19

In terms of security-related harm to persons, 2012/13 was the best performing year. Figure 57 shows that both 2018/19 injuries and fatalities increased by more than 400 per cent compared to 2012/13.
